# HOLY LOCH FLEET MOORING UNDERWATER INSPECTION REPORT

JUNE 1984

OCEAN ENGINEERING  
AND CONSTRUCTION PROJECT OFFICE  
CHESAPEAKE DIVISION  
NAVAL FACILITIES ENGINEERING COMMAND  
WASHINGTON, DC 20374

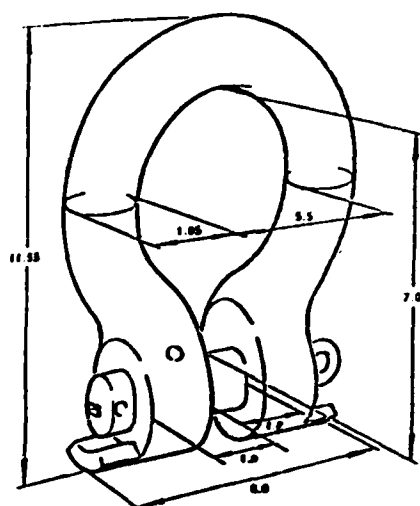
**BUOY RING SHACKLE**

- o All chain measurements were greater than 90 percent of their original wire diameter.
- o The bow buoy ring shackle (see Annex C) has a 1/4-inch-deep groove worn into its inner surface.
- o It was noted that British and U.S. Navy chain and hardware are being used together. See Annex C.
- o The bow buoy has a slight list which may be due to a loss of water tight integrity. The cause of this list should be investigated at the earliest possible time.
